DESCRIPTIVE REPORT
(HYDROGRAPHIC)

Type of Survey HYDROGRAPHIC
Field No. AHP-40-1-75
Office No..... H-9511

State FLORIDA
General Locality WEST COAST
Locality NORTHWEST OF TARPON SPRINGS

DESCRIPTIVE REPORT
TO ACCOMPANY
HYDROGRAPHIC SURVEY H-9511 (AHP-40-1-75)

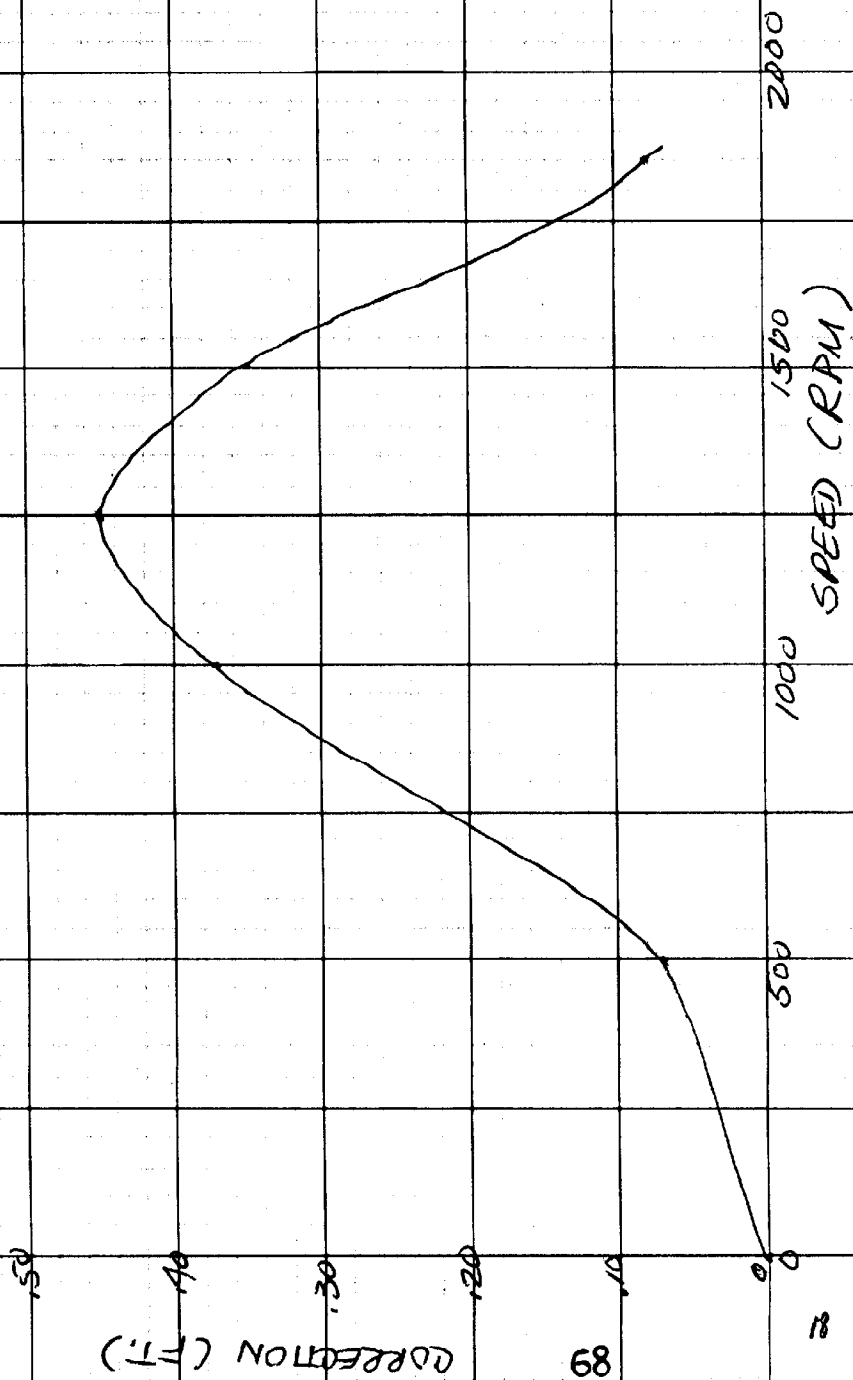
SETTLEMENT AND SQUAT
NOAA LAUNCH 1255
16 JAN 75

Settlement and Squat Determination
 NOAA Launch 1255
 16 January 1975
 Egmont Key, Florida

<u>RPM's</u>	<u>Stop</u>	<u>Out</u>	<u>Back</u>	<u>Stop</u>	<u>Average Stop</u>	<u>Average At Speed</u>	<u>Settlement & Squat</u>
(Idle)	500	2.36	2.43	2.40	2.33	2.34	2.41	+0.07
	1000	2.33	2.68	2.70	2.32	2.32	2.69	+0.37
	1250	2.32	2.76	2.74	2.27	2.30	2.75	+0.45
	1500	2.27	2.60	2.64	2.28	2.27	2.62	+0.35
(Full)	1850	2.27	2.33	2.35	2.26	2.26	2.34	+0.08
